Wenchuan Earthquake May 12th, 2008

EERI/GEER Reconnaissance Team Field Report 8/3/08 to 8/11/08

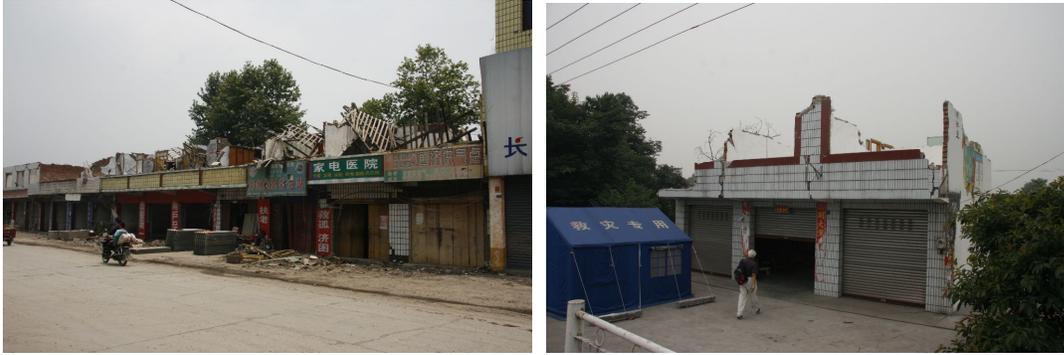
In small towns it was very common to see 2 or 3 stories of load bearing URM on top of one story of a reinforced concrete frame used for street-level storefronts. These buildings were principally large rectangular buildings, with precast hollow-core panel floors, bearing on transverse brick walls, and with longitudinal perimeter walls with significant openings. Roof system may be timber and shingle, similar to the pure URM buildings described above, or precast hollow-core panels. Similar to the pure URM structures, single-wythe load bearing masonry walls were frequently observed in the upper stories. Failures in these buildings were predominantly concentrated in the upper stories, with limited damage to the first story reinforced concrete frame (see examples below). This building type seemed to be “strong” in transverse direction, and “weak” in longitudinal direction, perhaps subject to “directionality effects”. Nonetheless, we know this building type to historically perform poorly in earthquakes.

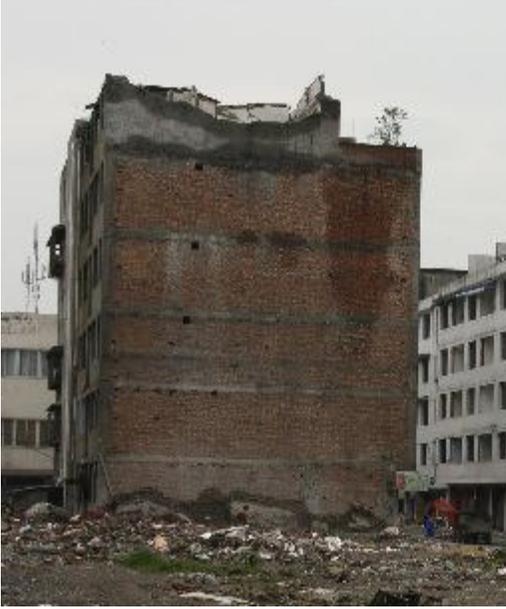
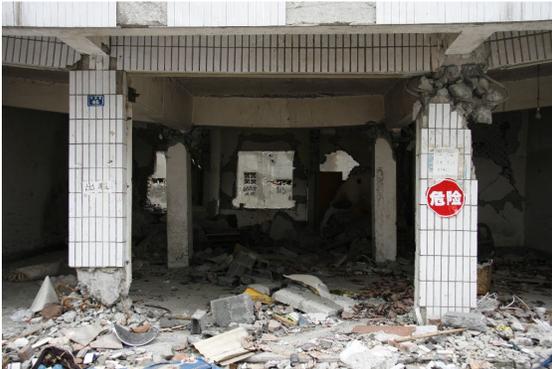
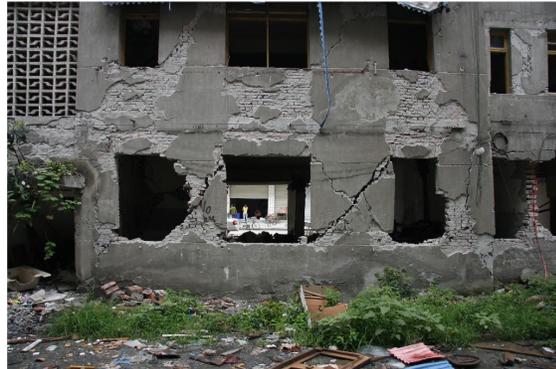
A mixed brick-concrete system was very commonly used for long rectangular three to seven story apartment buildings in larger cities such as Dujiangyan. Standard drawings for similar mixed brick-concrete buildings (Southwest 03G601), indicate that in addition to a reinforced concrete ring beam, reinforced concrete vertical elements (columns) should be located at maximum spacing less than or equal to 3.9 m along the load bearing walls, similar to “confined masonry” used in many parts of the world. Observations in the field, however, suggested that the damaged buildings incorporated a ring beam with widely spaced vertical elements, frequently only located at the corners of the building (see example below). Due to the lack of confinement from the limited vertical elements, this building type tended to behave as an unreinforced masonry structure. The masonry walls were typically two wythes thick or 24 cm. Precast hollow core panels are used for floors and roofs, bearing on reinforced concrete beams. Transverse reinforcement in the concrete elements were typically # 3 undeformed bars with fairly wide spacing of 12” or greater. There is no connection of floor planks to the bearing beams or to perimeter ring beam, except by contact, bearing and friction. There is great variation in the size of concrete elements (columns as small as 8” nominal, or thickness of the brick wall) and “random” spacing. As with other URM buildings, there seems to be “directional” strength in the transverse axis due to the regular spacing of brick shear walls, and weaker in the longitudinal direction, with only the two perimeter long walls with significant openings. In some buildings of this type, there were internal longitudinal corridor walls, so longitudinal “directional weakness” is not so clear. In street-front zones, non-code conforming soft-story conditions are created at the ground floor by business “storefronts”. Storefronts were frequently formed using reinforced concrete frames; however, in many damaged structures the frame only supported the front half of the building with the back of the building supported by load bearing masonry walls. Figure below shows damage to the front and back of one such building in Dujiangyan. The 1989 Chinese Building Code has very specific provisions for this building type.

The performance of the mixed brick-concrete building type varied greatly from “life safe” (with significant and perhaps unreparable damage) to partial collapse and total collapse. This is where the “lateness” of the reconnaissance trip may have affected our survey of damage: so many buildings had been demolished. We saw many buildings with first story collapses (middle school in Yingxiu and factory housing in Dujianyan) and many top floor collapses, though these were often of the Type I UMB building type. There does seem to be evidence of directionality effects (strong forces in the direction of the building’s “weak axis”, though this was never conclusive and consistent observation. We saw evidence of orthogonal behavior (forces at a skewed angle to the principal building axes). This may have resulted in torsional behavior, yet hard to make engineering sense of this given the lack of “real” floor and roof rigid diaphragms. We observed many ground floor collapses even without soft story store front conditions. Other observations of the performance of this building type include: building “ends” with severe damage, perhaps coinciding with stair well construction; ‘end of block” effects; and severe damage or partial collapse at zones of detailing or material defect. Again, many of these performance observations were hard to turn into “sure” conclusions due to the nature of the “perishable data.”

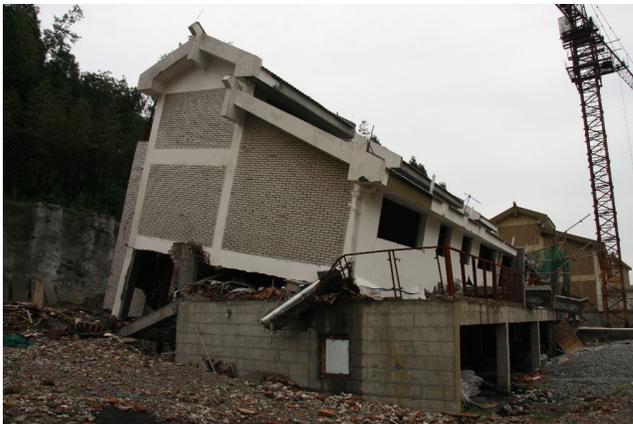
Better performance was observed in buildings with all brick or concrete block infill, or where hollow clay tile was only used in the upper stories. The figure below shows the collapse of a building with a hollow clay tile infill at the ground level.

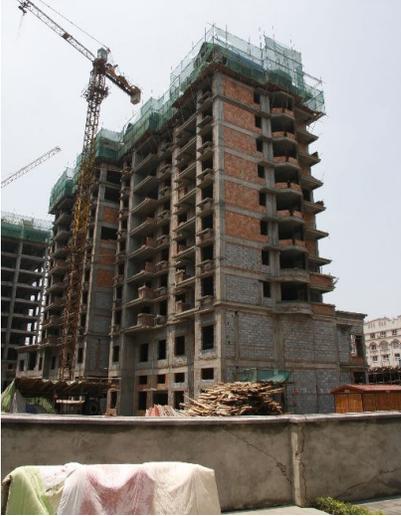
Generally, the performance of concrete moment frame buildings was very good, of the building types we observed, especially sometimes in relation to the very poor performance of adjacent buildings (3-story middle school in Bailu; dining hall in Yingxi middle school). New twelve-story concrete frame-wall buildings performed exceptionally well (see below) in Joling where modest damage to URM buildings was observed.

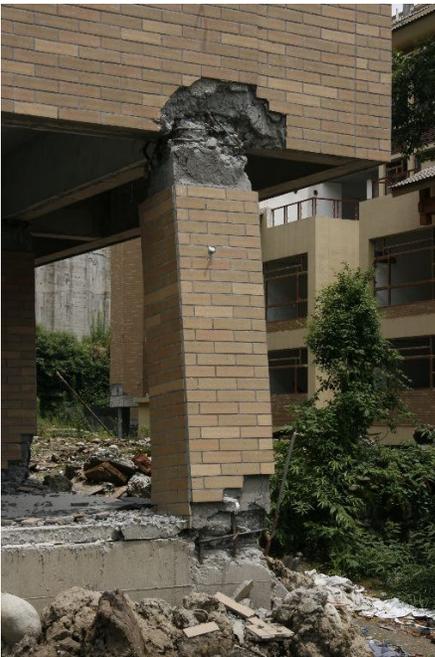
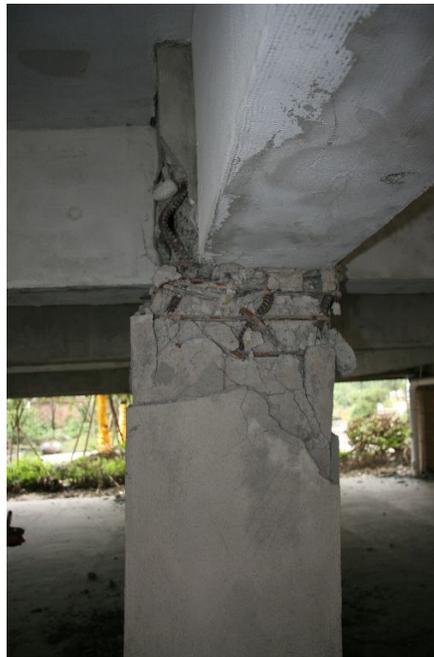
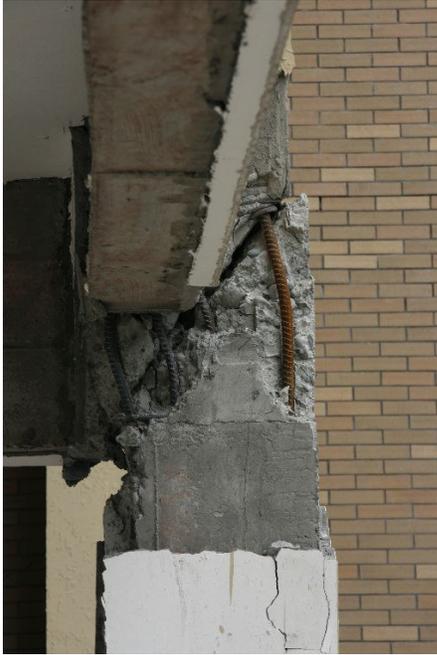
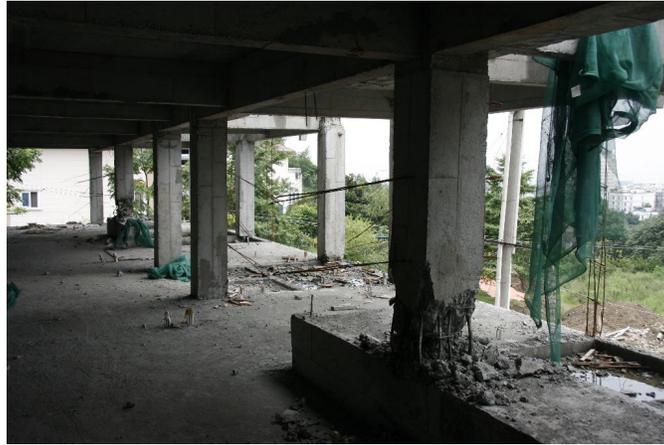
Significant damage to concrete moment frame structures were observed at a condominium complex under construction at the Yuan Shan City Garden in Dujiangyan. As shown in the figures below, the following damage typical of non-ductile concrete structures was observed in this complex: plastic hinging in soft first story columns; buckling of column reinforcement in interior joints with little or no transverse reinforcement; shear failure in exterior beam-column joints; and shear failures in short columns created by nonstructural concrete elements.
